NASA TN D-2685

SEALED-FOAM, CONSTRICTIVE-WRAPPED,
EXTERNAL INSULATION SYSTEM
FOR LIQUID-HYDROGEN TANKS
OF BOOST VEHICLES

by Lewis Research Center Staff

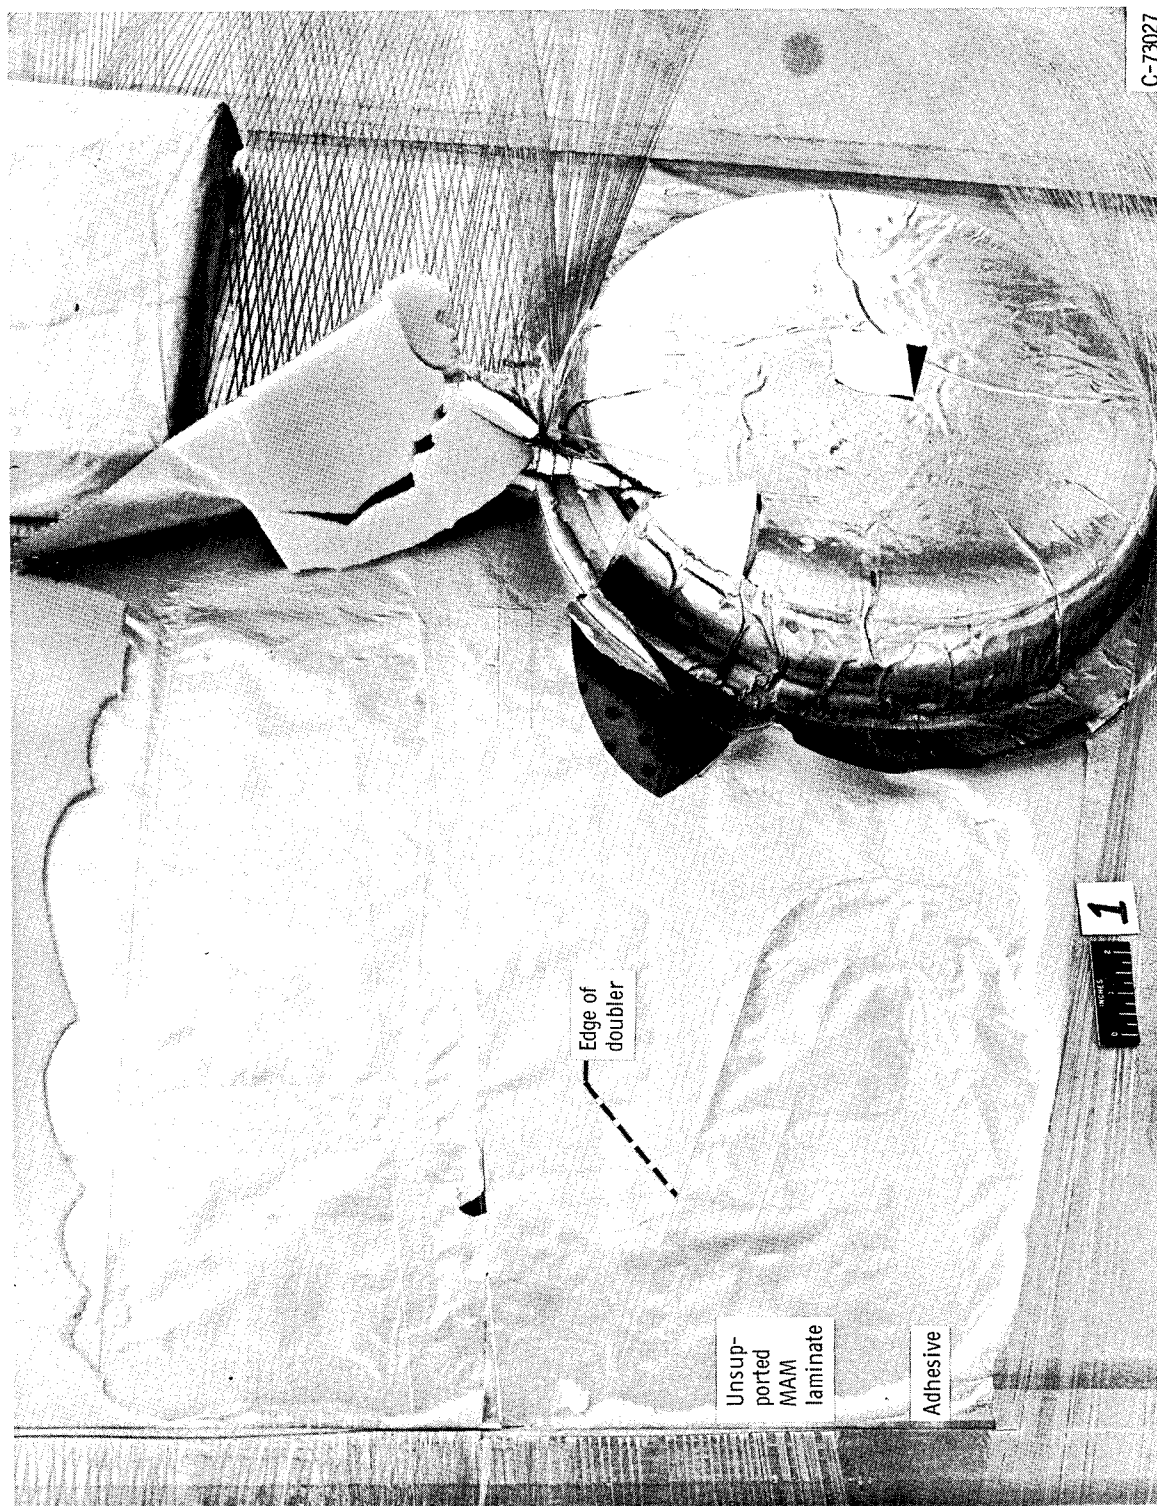
(a) Before examination.

Figure VIII-9. - Blistered area 1.

(b) MAM laminate folded back exposing cracked foam.

(c) Cracked foam removed.

(d) Inside layer of MAM laminate exposed showing impression of doubler.
